DEPARTMENT OF TRANSPORTATION

Quality Assurance and Source Inspection

Contract #: 04-0120F4Cty: SF/ALA Rte: 80 PM: 13.2/13.9File #: 69.28**WELDING INSPECTION REPORT****Resident Engineer:** Pursell, Gary**Address:** 333 Burma Road**City:** Oakland, CA 94607**Report No:** WIR-006469**Date Inspected:** 25-Apr-2009**Project Name:** SAS Superstructure**OSM Arrival Time:** 1845**Prime Contractor:** American Bridge/Fluor Enterprises, a JV**OSM Departure Time:** 645**Contractor:** Zhenhua Port Machinery Company, Ltd (ZPMC), Changxing Island **Location:** Shanghai, China**CWI Name:** See Below**CWI Present:** Yes No**Inspected CWI report:** Yes No N/A**Rod Oven in Use:** Yes No N/A**Electrode to specification:** Yes No N/A**Weld Procedures Followed:** Yes No N/A**Qualified Welders:** Yes No N/A**Verified Joint Fit-up:** Yes No N/A**Approved Drawings:** Yes No N/A**Approved WPS:** Yes No N/A**Delayed / Cancelled:** Yes No N/A**Bridge No:** 34-0006**Component:** OBG and Tower Fabrication**Summary of Items Observed:**

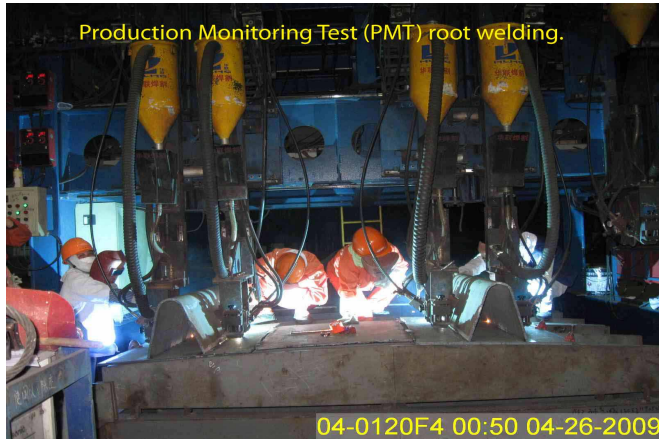
QA Inspector observed ZPMC NDE inspector Mr. Tang Xingshan performing ultrasonic of each of the welds in the areas where Mr. Bo had marked for PMT testing. Following ZPMC's UT acceptance the QA Inspector marked a total of 10 locations where macroetch samples are to be obtained. ZPMC then cut and prepared macroetch samples. ZPMC QC CWI Inspector Mr. Sun Bo and ABF representative Ms. Lu Yun visually inspected these macroetch samples and documented their acceptance on the ZPMC Production Monitoring Test Plate Inspection Report sheet dated 04-26-2009. The QA Inspector visually inspected each of these macroetch samples and items observed by the QA Inspector appear to comply with project specifications. See the photograph below for additional information.
